Public Health Assessment

Beloit Corporation

Rockton, Winnebago County, Illinois

EPA Facility ID# ILD021440375

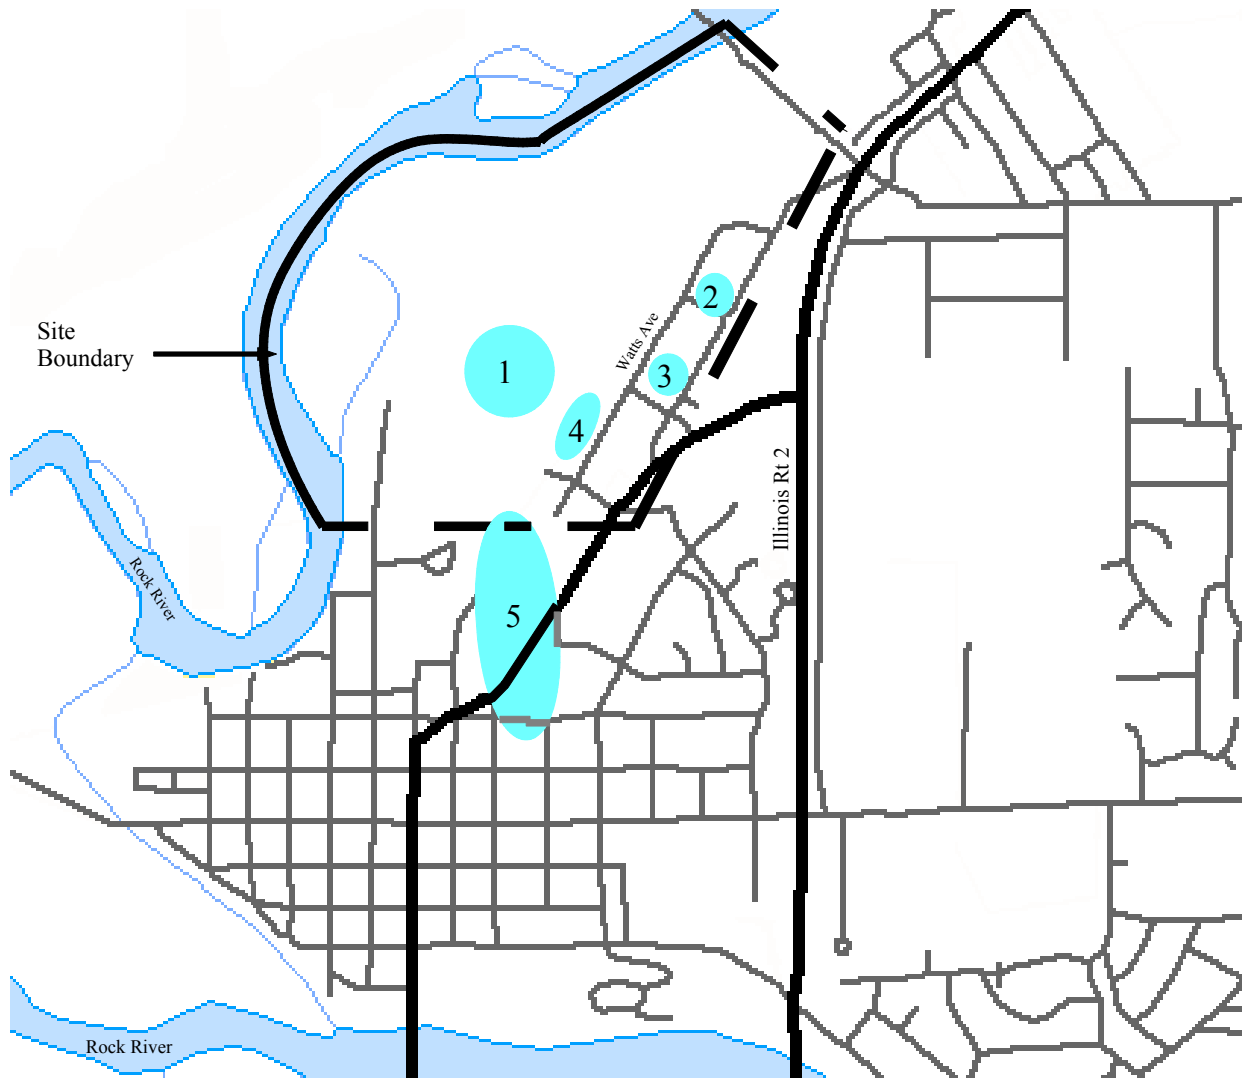
BELOIT CORPORATION  
APPROXIMATE PLUME LOCATIONS

Plume Number	Major Contaminants
1.	PCE and TCA
2.	Chloroform
3.	TCE
4.	PCE, TCE and TCA
5.	TCE and TCA

There appears to have been five separate groundwater contamination plumes related to this site. Four of the five plumes are located within site boundaries (Attachment 3). The fifth plume is migrating off the site into the Village of Rockton [2].
